BC Accident Statistics

Accidents / Fatalities

NTSB Data (as of 4/16/2013)

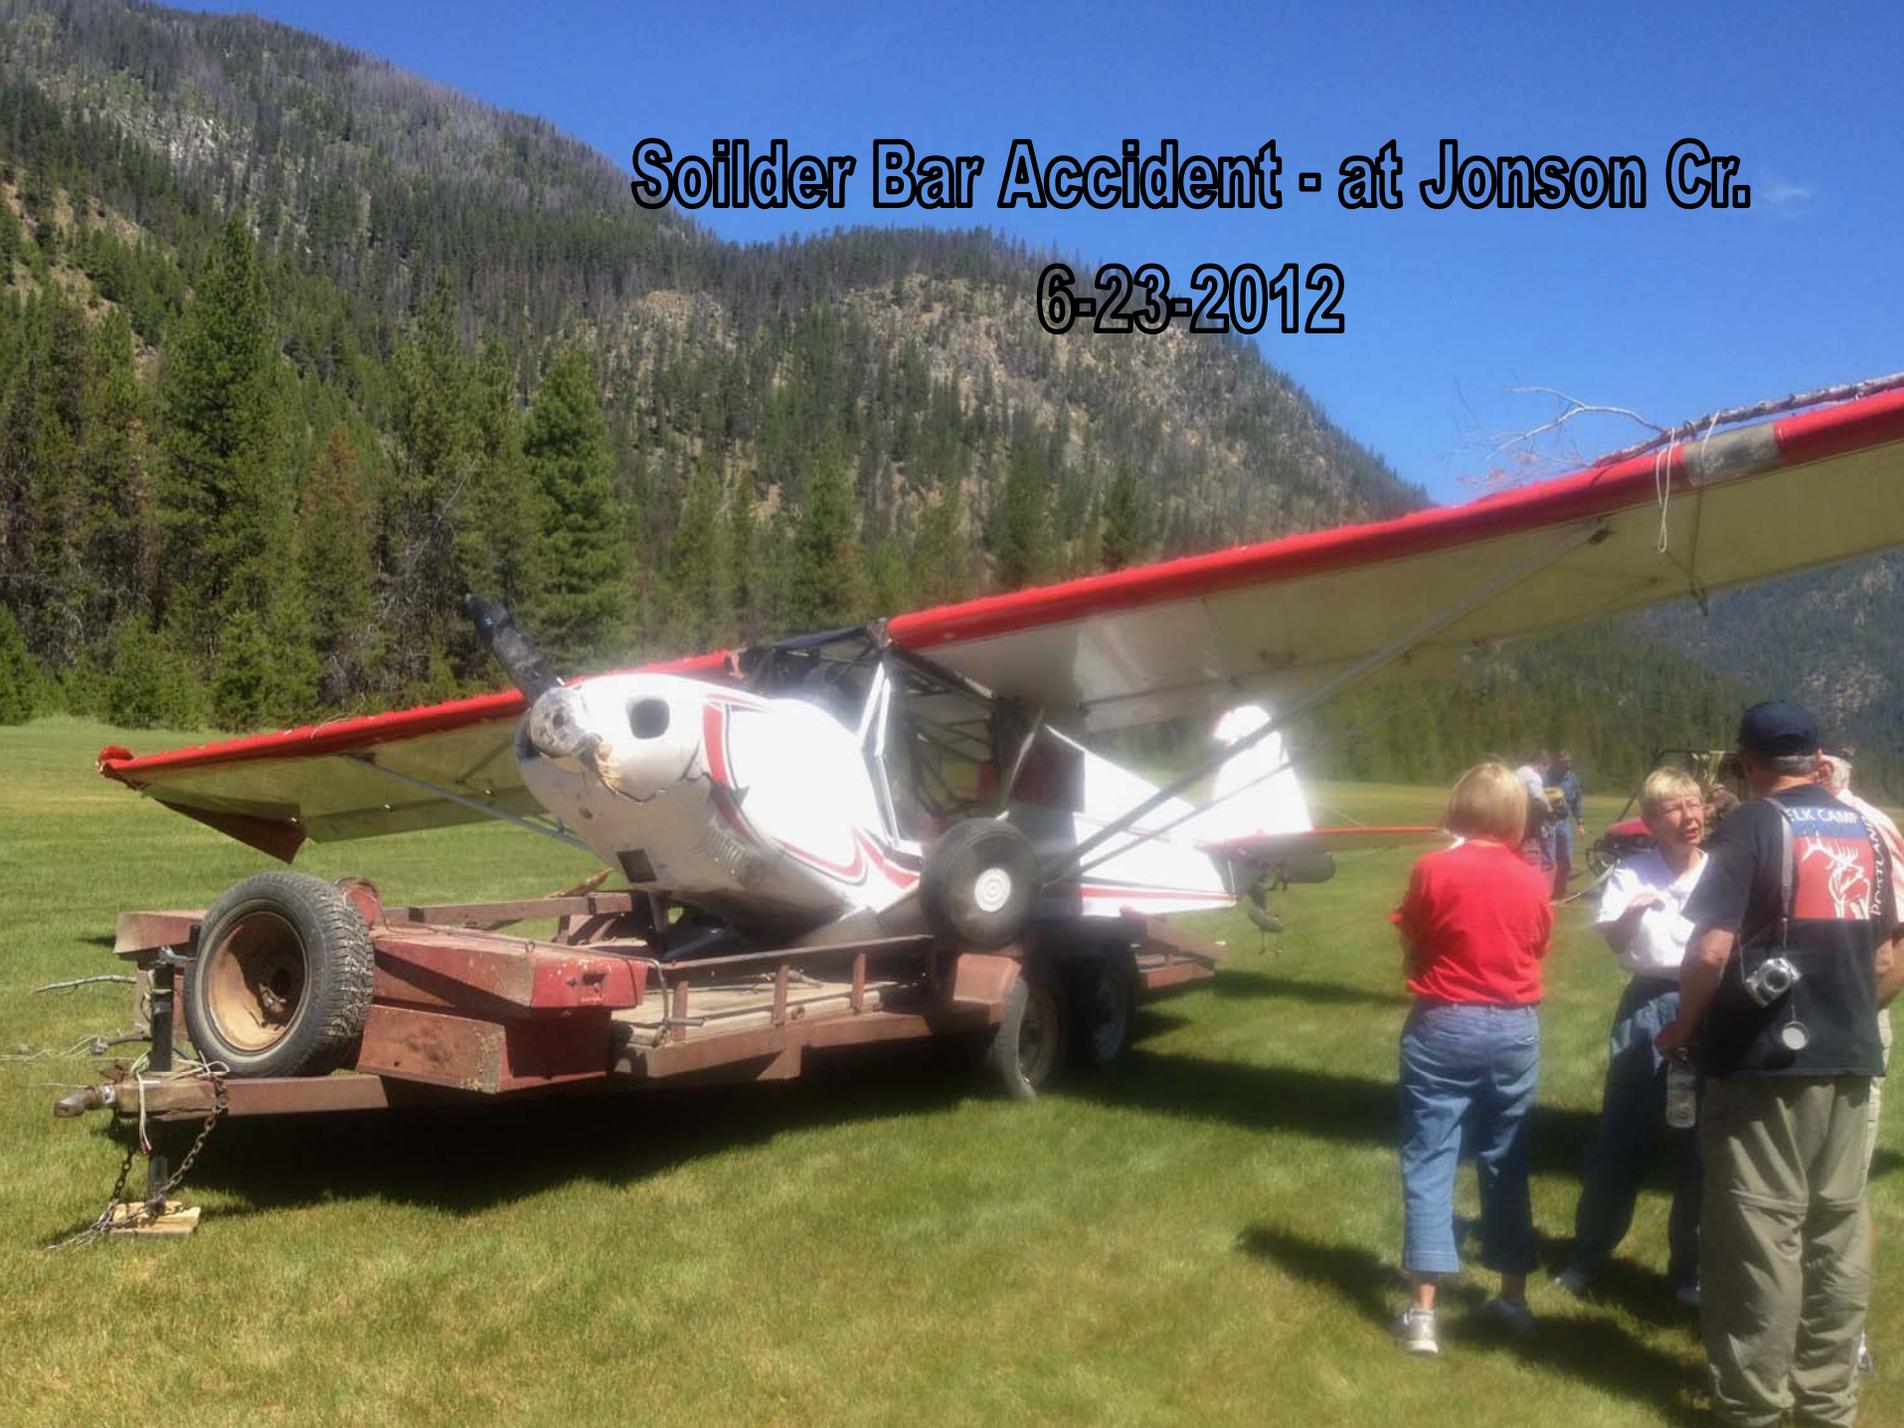
Soilder Bar Accident - at Jonson Cr.

- Soilder Bar 6/23 about 1200 mountain daylight time, a Cox PA 18 amateur built airplane, N13VC, veered off the runway and collided with a pile of rocks during takeoff from the Soldier Bar Airport, Soldier Bar, Idaho. The commercial pilot, the sole occupant, was not injured; the airplane sustained substantial damage. Visual meteorological conditions prevailed. During the takeoff roll, he experienced a loss of control and could not steer the airplane. He veered to the left and continued off the runway surface. The airplane encountered a pile of rocks and nosed over, spinning left. The pilot further stated that he believed that he lost controllability due to the left brake dragging or a tailwheel malfunction.

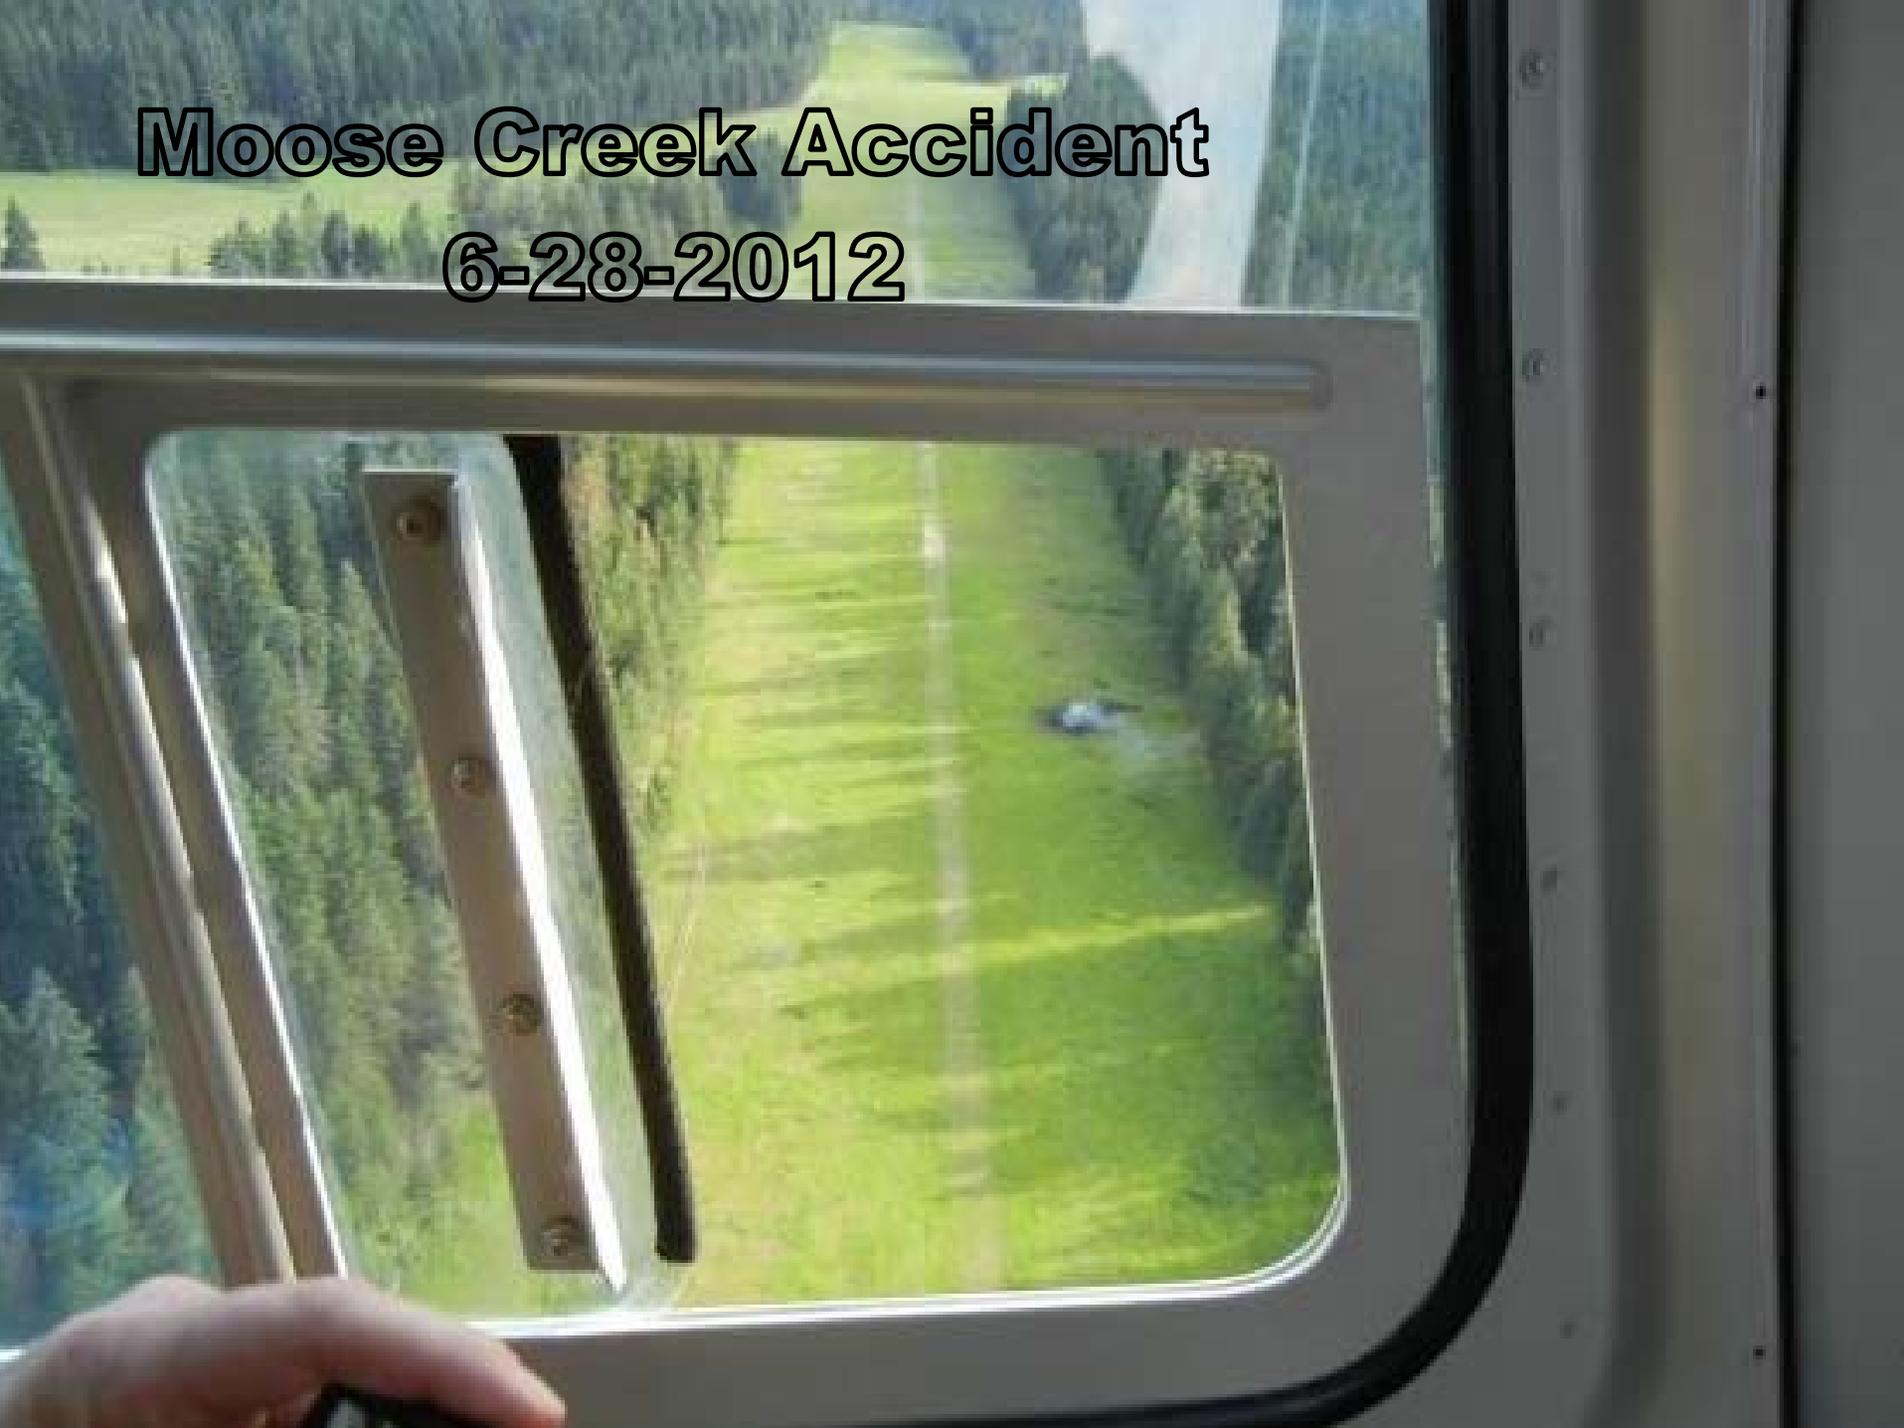
Moose Creek Accident

- Moose Cr. 6/28, about 1500 Pacific daylight time, an AVIAT A-1C-180 airplane, was substantially damaged following impact with terrain during takeoff initial climb at the Moose Creek. The certified private pilot received fatal injuries, and the sole passenger was not injured. Visual meteorological conditions. While attempting to depart the area due to an approaching storm the pilot appeared to have lost control of the airplane on initial climb. The airplane subsequently impacted terrain, after which it was consumed by fire. Other reports is that the pilol was well experienced and had been into MC several times. RAW's data reported gusty winds around the time of the accident.

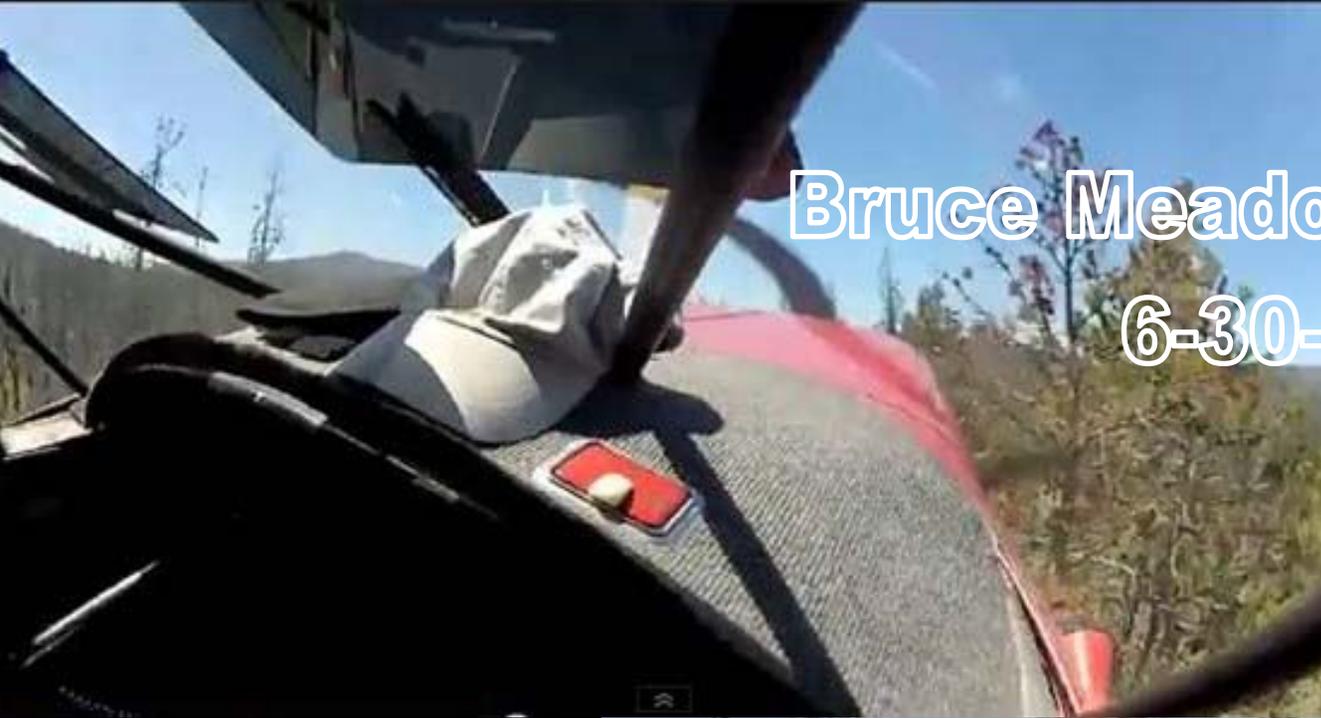
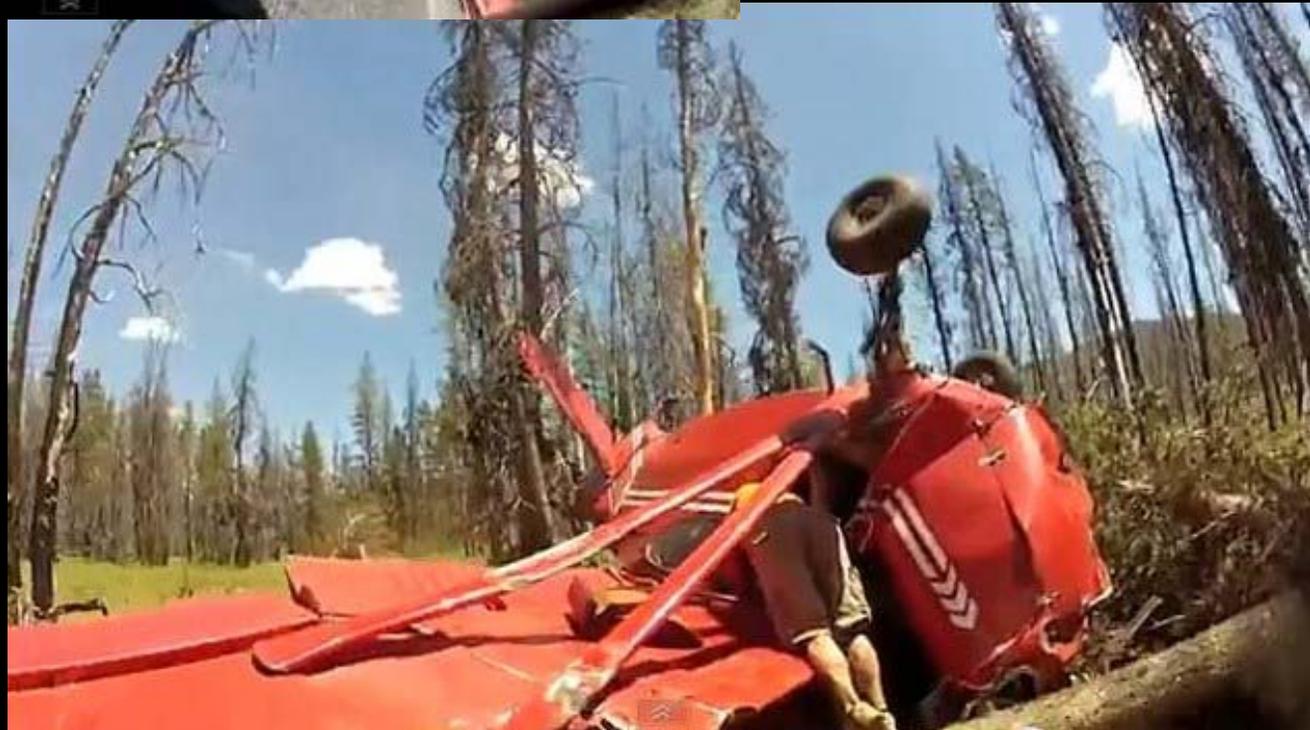
Bruce Meadows Accident

- Bruce Meadows. On June 30, 2012, about 1405 mountain daylight time, a Stinson 108-3, was substantially damaged after impacting terrain during initial climb near the Bruce Meadows Airport (U63), Stanley, Idaho. The certified commercial pilot sustained serious injuries, and the three passengers sustained minor injuries. Visual meteorological conditions prevailed for the local flight.

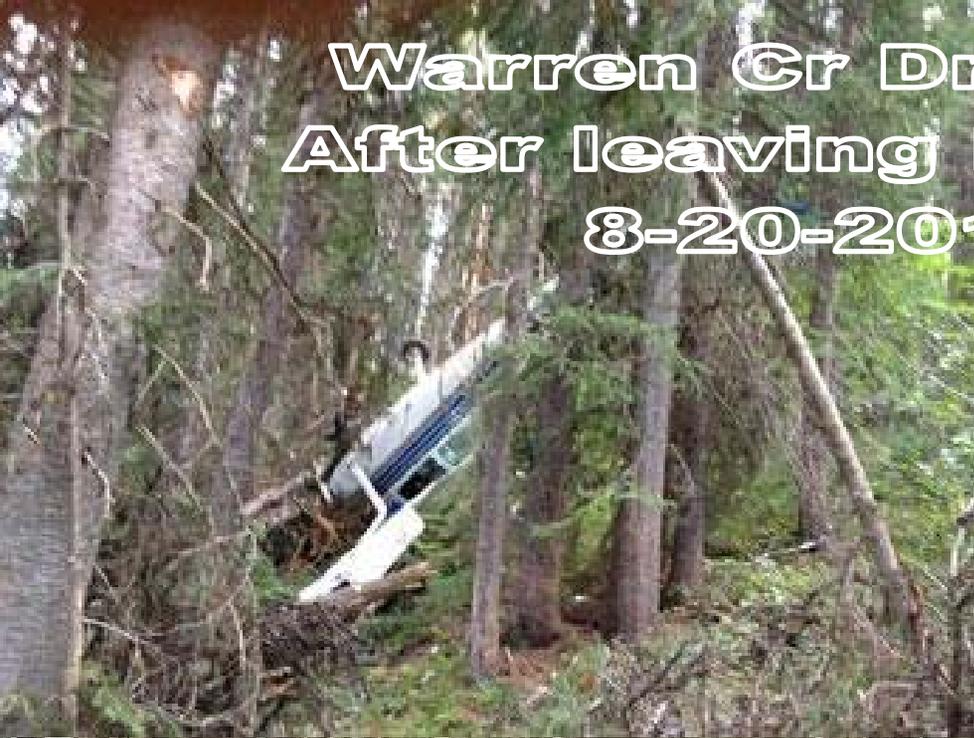
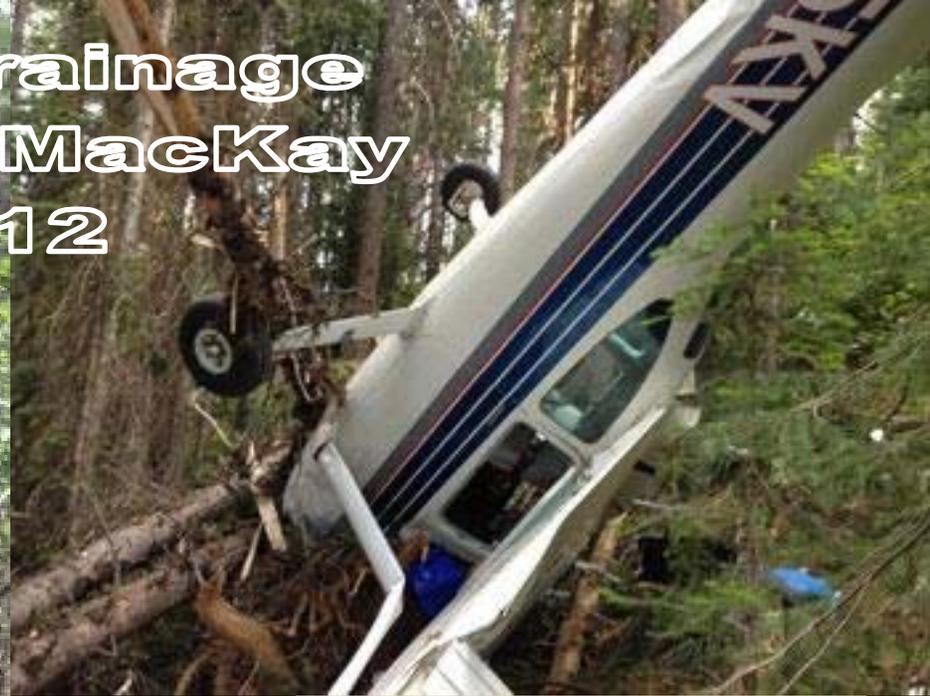
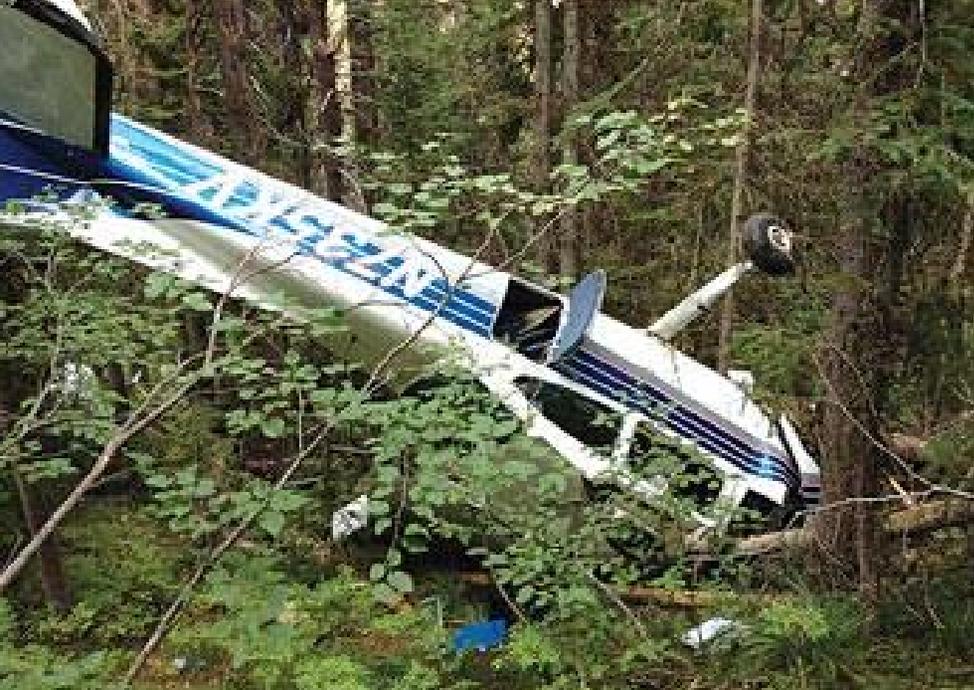
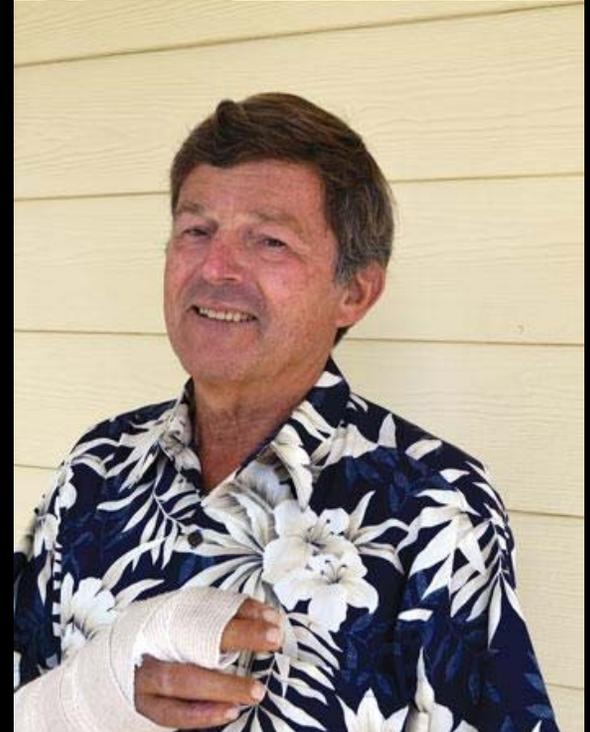
Warren Cr Drainage
After leaving MacKay
8-20-2012

- McCall / Warren 8/20 About 1050 mountain daylight time, a Cessna 182Q, N735KV, sustained substantial damage when it impacted trees and terrain during climb in rising mountainous terrain near McCall, Idaho. The flight instructor and his commercial pilot-rated student both received minor injuries. Visual meteorological conditions prevailed for the instructional cross-country flight, which had originated about 15 minutes before the accident out of MacKay Bar. The flight instructor stated that they were flying up a mountain canyon when the terrain elevation increase exceeded the climb performance of the airplane. The airplane began impacting tree tops and subsequently impacted terrain. The density altitude was about 8,600 feet. The instructor suggests they climb up the Warren River drainage basin instead of a direct climb to 8,000 feet, since it will be shorter. But they missed a turn. Unable to out climb the rising incline, and with no place to safely land, the pilot concentrates on keeping the wings of the plane level while he looks around for new growth pines. With trees everywhere, it is the younger ones with their flexible branches that give the best chance for survival.

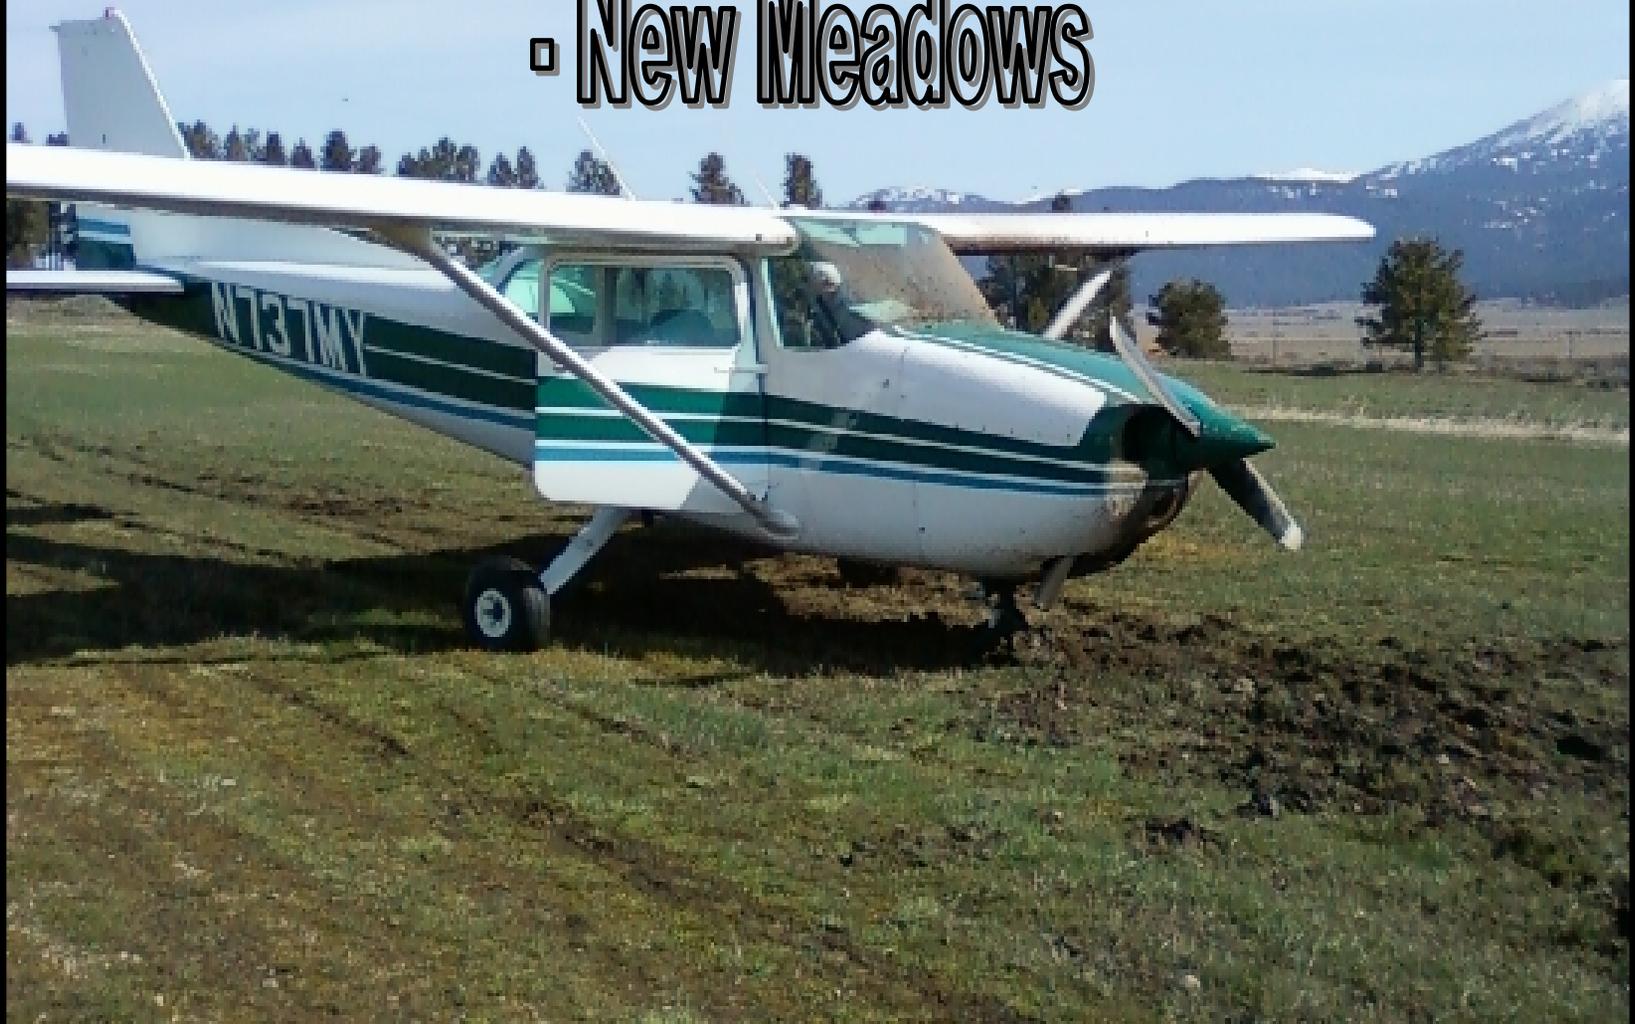
- New Meadows

C182 - Overloaded - tailwind - take off stall

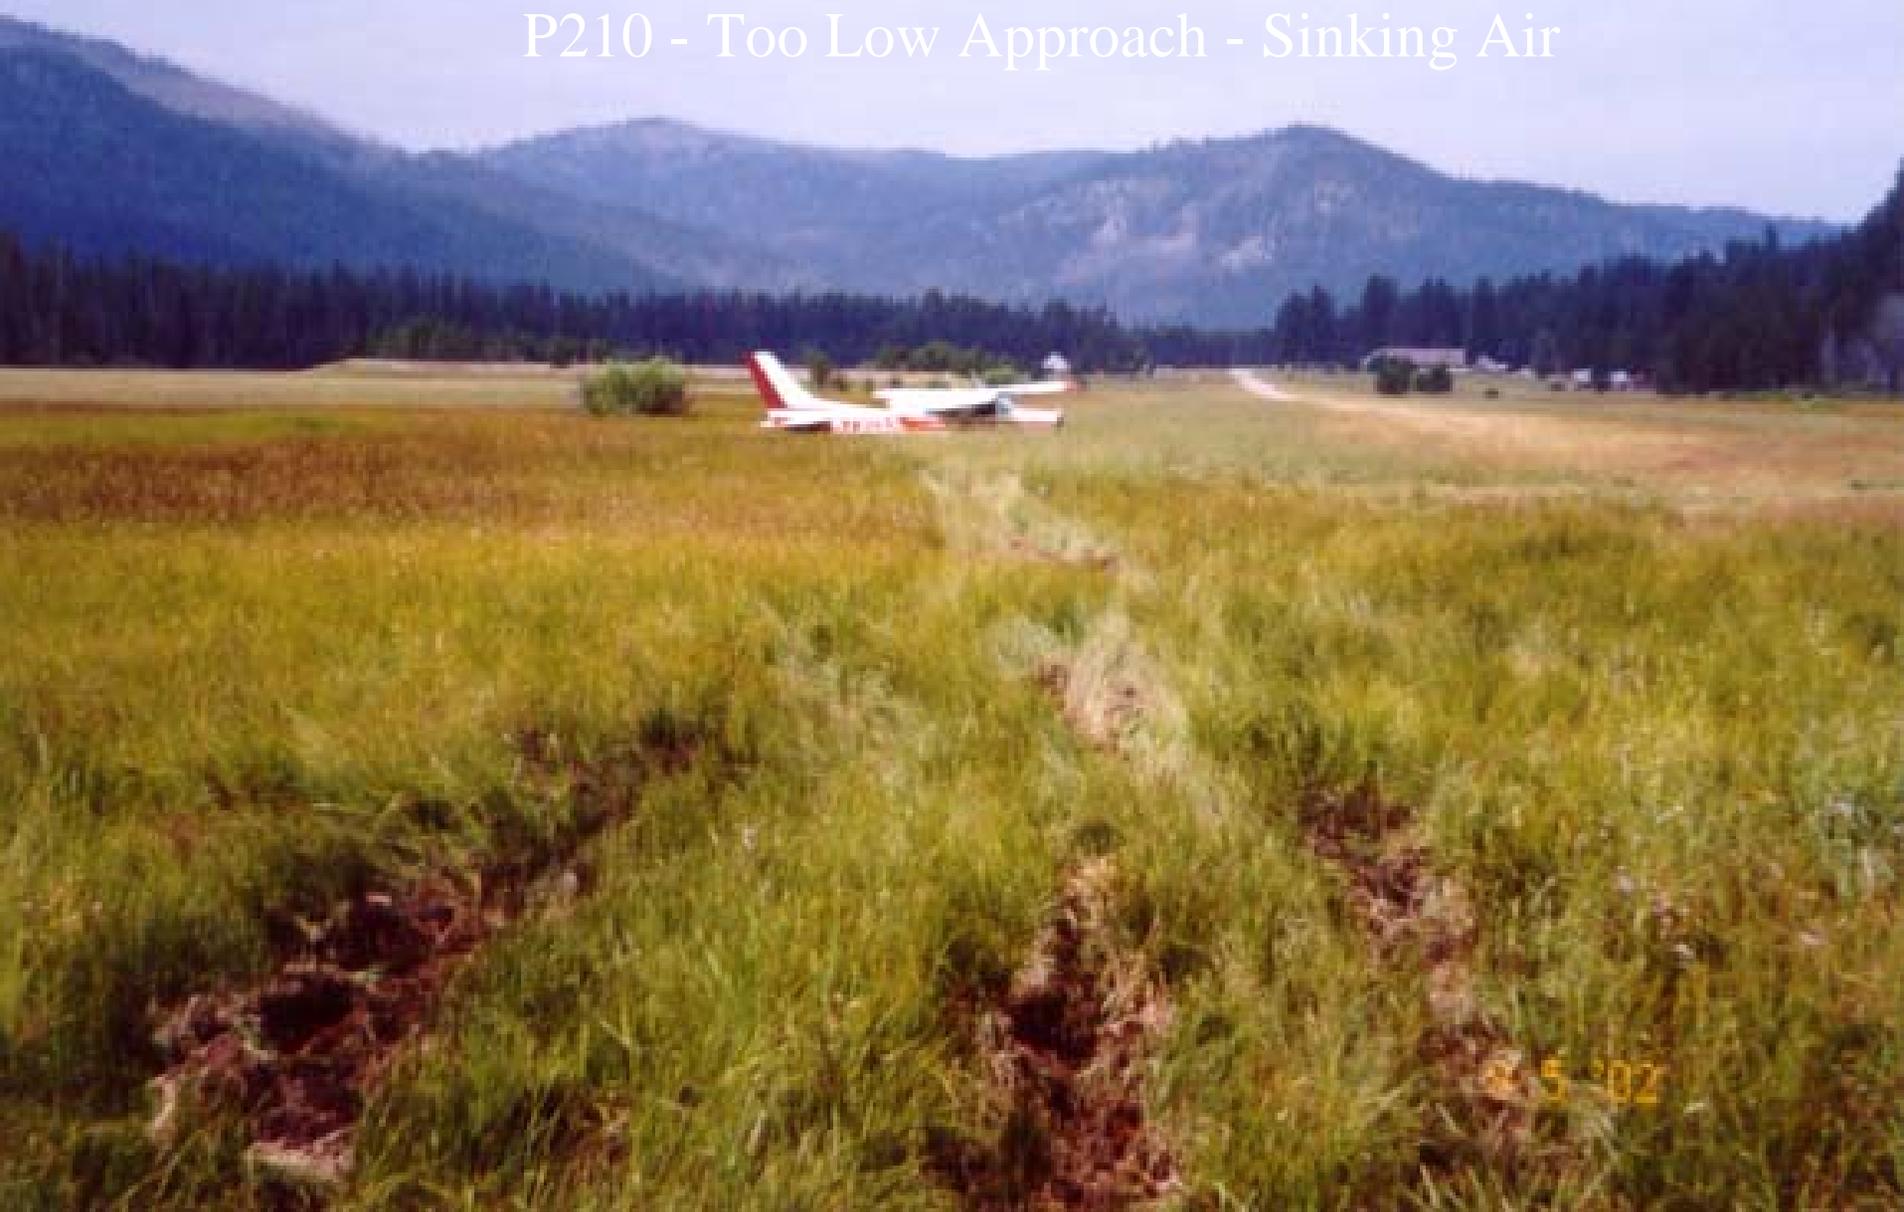
P210 - Too Low Approach - Sinking Air
